Aviation Investigation Final Report

| Location: | Albany, Oregon | Accident Number: | WPR21FA265 |
| Date & Time: | July 9, 2021, 20:51 Local | Registration: | UNREG |
| Aircraft: | North Wing Mustang | Aircraft Damage: | Substantial |

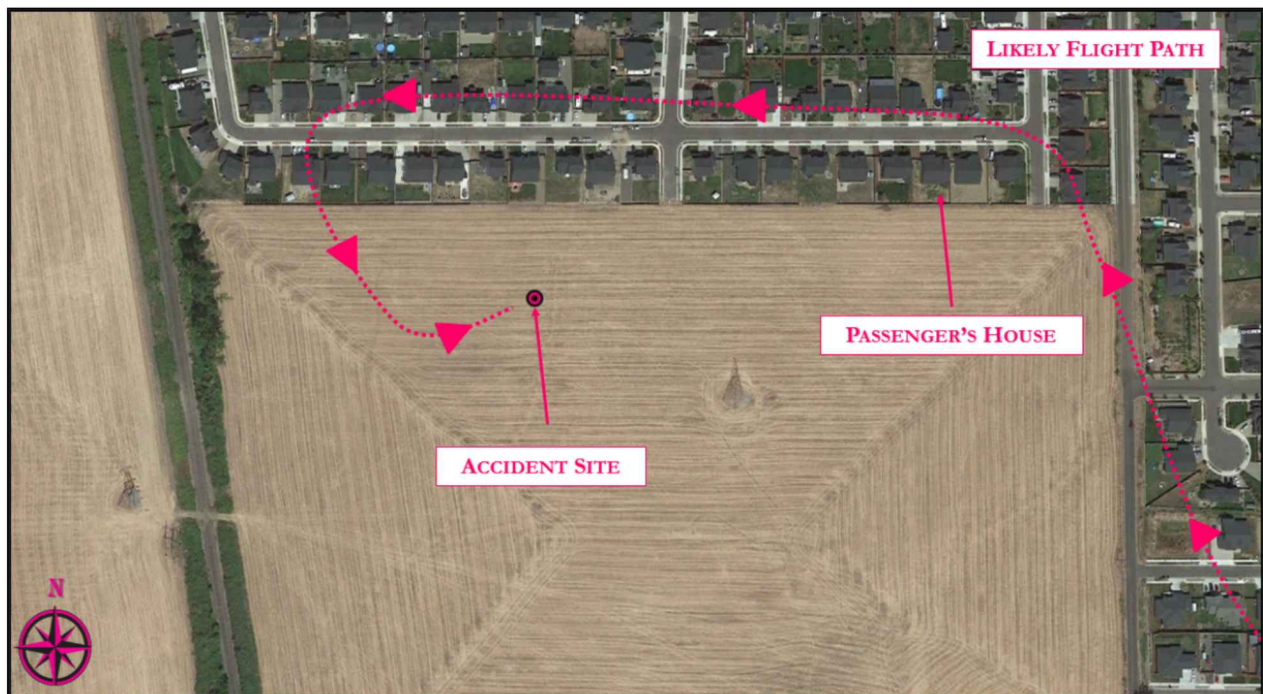
Figure 1. Likely flightpath impact

According to family members, the pilot and passenger departed from the pilot's home airport in Albany, Oregon. After overflying the pilot's home, located about 4,000 ft north of the airport, the aircraft continued northeast for about 3.3 miles. The aircraft then turned left and flew close to the passenger's home before impacting the ground (see figure 1).

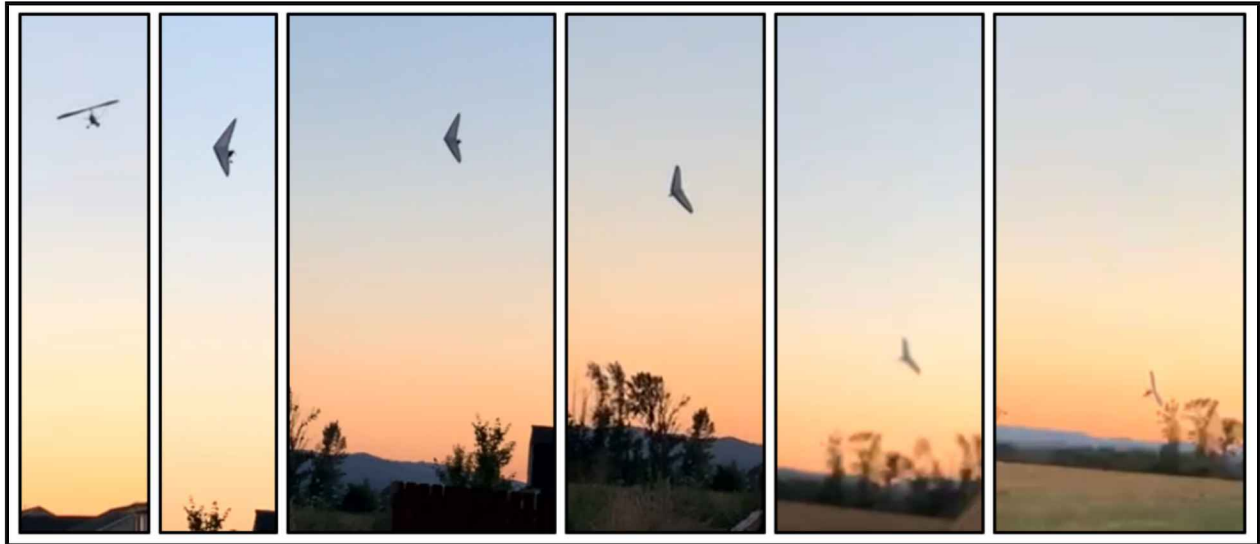
Figure 2. Excerpts from a mobile phone video.

Several witnesses on the ground recorded the airplane's maneuvers on their mobile phone devices. A review of those videos showed that the aircraft banked to the left in an almost 90° turn. The left wing continued to drop downward, and the aircraft descended toward the ground as the turn tightened. The aircraft impacted terrain in a left-wing-low attitude (see figure 2).

A video study was performed on the captured imagery to estimate the aircraft's ground track, groundspeed, altitude, and roll angle. The estimated groundspeed when the aircraft initiated a left turn was 60 ± 3 mph (52 ± 3 knots). The altitude above ground level was 233 ± 10 ft at that time. The left-wing-down roll angle increased to almost 90° about 6 seconds after the turn was initiated. The aircraft impacted the ground about 9 seconds afterward. The engine speed was within its normal range, and the aircraft roll angle was increasing at a high rate.
