Staff Report

Natural Resources Impact Review

NR-03-23

**BRANDIS MEADOWS TOWNHOME SUBDIVISION
 NATIVE RESOURCE BUFFER REDUCTION PLAN**

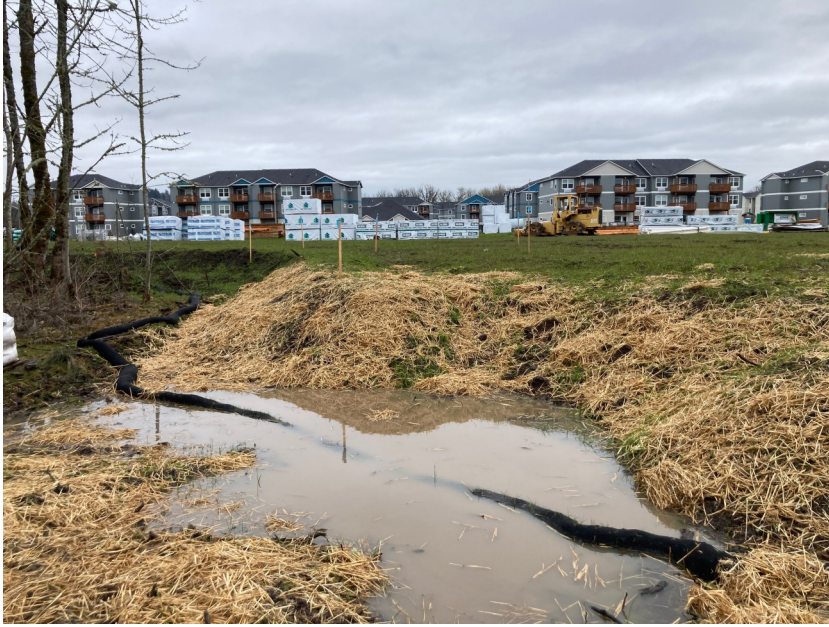
Photo A:

Looking east at the edge of Wetland B.

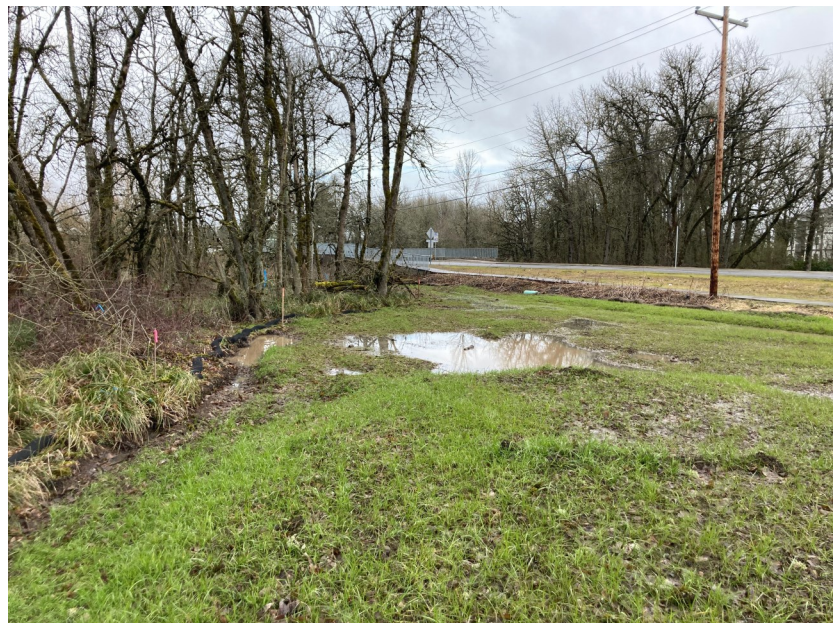
Looking northwest at the edge of grading south of Knox Butte Road.

(Photo taken: March 2, 2023)

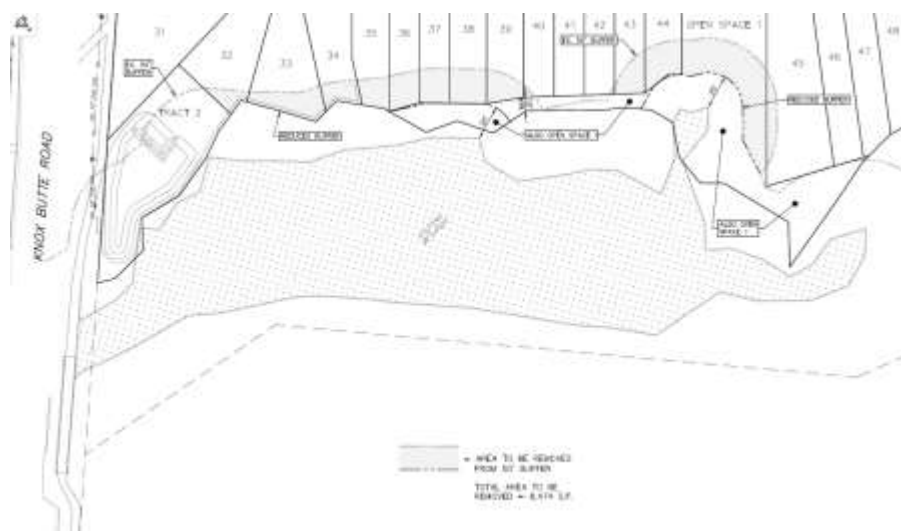
The applicant is also requesting a reduction in the 50-foot riparian corridor buffer to 25 feet. See attached site plans.

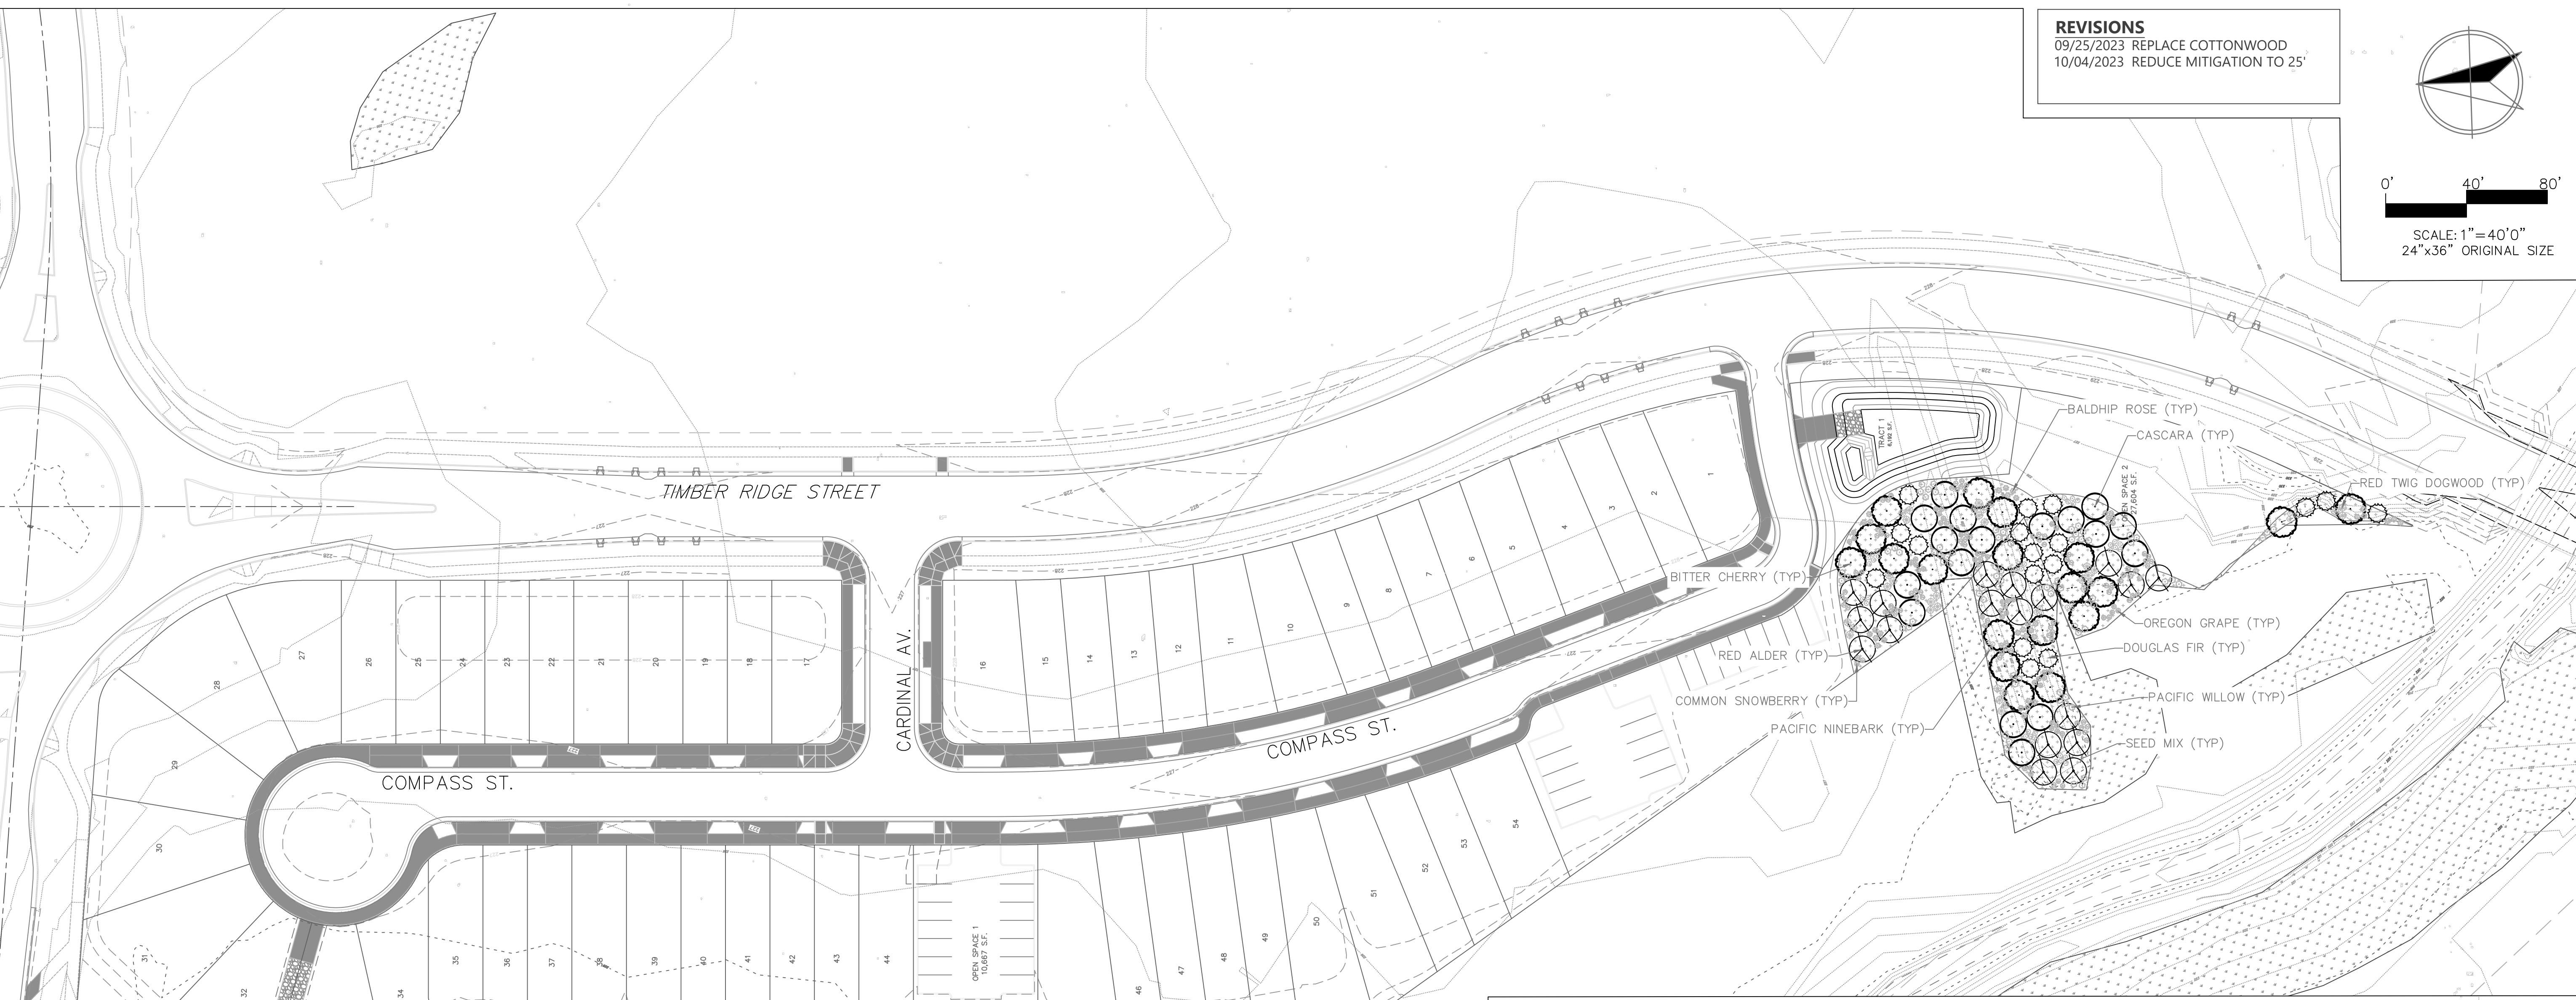
JOB NO.
 DATE 08/21/2023
 DESIGN BY AL/NP
 CHECKED BY AL
 SHEET
 LS-1

SYMBOL	QTY	BOTANICAL NAME	COMMON NAME	SIZE	SPACING
TREES					
	45	ALNUS RUBRA	RED ALDER	2 GAL / 3' HT. MIN.	AS SHOWN
	40	RHAMNUS PURSHIANA	CASCARA	2 GAL / 3' HT. MIN.	AS SHOWN
	42	PRUNUS EMARGINATA	BITTER CHERRY	2 GAL / 3' HT. MIN.	AS SHOWN
	43	PSEUDOTSUGA MENZIESII	DOUGLAS FIR	2 GAL / 3' HT. MIN.	AS SHOWN
SHRUBS					
	115	CORNUS SERICEA	RED TWIG DOGWOOD	1 GAL.	AS SHOWN
	137	MAHONIA AQUIFOLIUM	OREGON GRAPE	1 GAL.	AS SHOWN
	154	PHYSOCARPUS CAPITATUS	PACIFIC NINEBARK	1 GAL.	AS SHOWN
	134	ROSA PISOCARPA	BALDHIP ROSE	1 GAL.	AS SHOWN
	151	SALIX LUCIDA SSP LASIADRA	PACIFIC WILLOW	1 GAL.	AS SHOWN
	145	SYMPHORICARPOS ALBUS	COMMON SNOWBERRY	1 GAL.	AS SHOWN
GROUNDCOVER					
	AS NEEDED	SEED MIX: NATIVE UPLAND MIX BY PROTOME LAWN SEED. BLUE WILDRYE (ELYMUS GLAUCUS) 34%; MEADOW BARLEY (HORDEUM BRACHYANTHERUM) 33%; CALIFORNIA BROME (BROMUS CARINATUS) 33%. APPLY AT A RATE OF 1 LB PER 1,000 SF (30-40 LBS PER ACRE) TO ANY BARE AREAS OVE 25 SQUARE FEET.

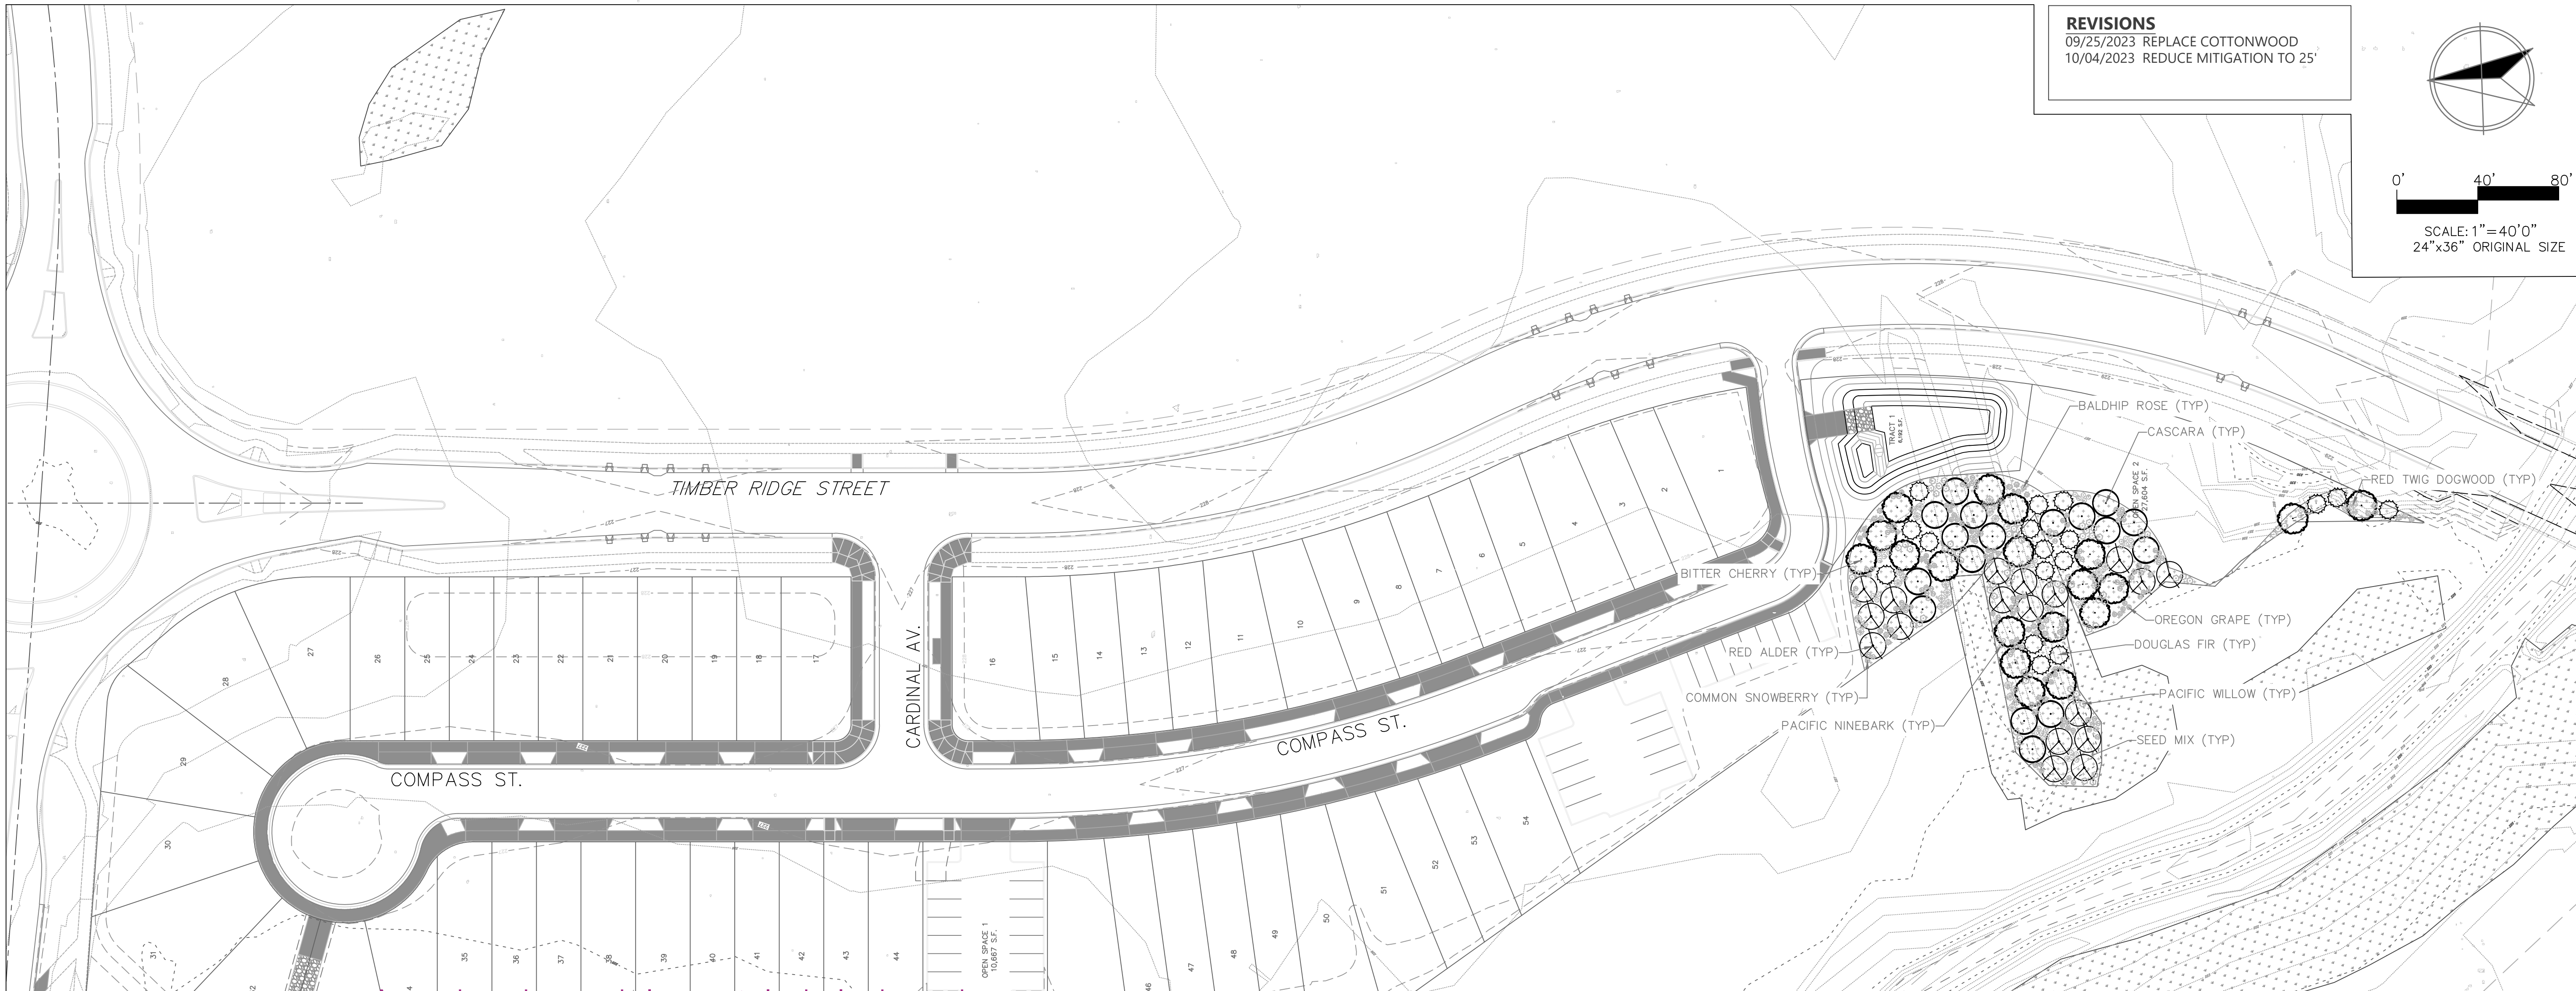
JOB NO.
 DATE 08/21/2023
 DESIGN BY AL/NP
 CHECKED BY AL
 SHEET
 LS-1

Areas shown in green below must also be landscaped

SYMBOL	QTY	BOTANICAL NAME	COMMON NAME	SIZE	SPACING
TREES					
	45	ALNUS RUBRA	RED ALDER	2 GAL / 3' HT. MIN.	AS SHOWN
	40	RHAMNUS PURSHIANA	CASCARA	2 GAL / 3' HT. MIN.	AS SHOWN
	42	PRUNUS EMARGINATA	BITTER CHERRY	2 GAL / 3' HT. MIN.	AS SHOWN
	43	PSEUDOTSUGA MENZIESII	DOUGLAS FIR	2 GAL / 3' HT. MIN.	AS SHOWN
SHRUBS					
	115	CORNUS SERICEA	RED TWIG DOGWOOD	1 GAL.	AS SHOWN
	137	MAHONIA AQUIFOLIUM	OREGON GRAPE	1 GAL.	AS SHOWN
	154	PHYSOCARPUS CAPITATUS	PACIFIC NINEBARK	1 GAL.	AS SHOWN
	134	ROSA PISOCARPA	BALDHIP ROSE	1 GAL.	AS SHOWN
	151	SALIX LUCIDA SSP LASIADRA	PACIFIC WILLOW	1 GAL.	AS SHOWN
	145	SYMPHORICARPOS ALBUS	COMMON SNOWBERRY	1 GAL.	AS SHOWN
GROUNDCOVER					
	AS NEEDED	SEED MIX: NATIVE UPLAND MIX BY PROTOME LAWN SEED. BLUE WILDRYE (ELYMUS GLAUCUS) 34%; MEADOW BARLEY (HORDEUM BRACHYANTHERUM) 33%; CALIFORNIA BROME (BROMUS CARINATUS) 33%. APPLY AT A RATE OF 1 LB PER 1,000 SF (30-40 LBS PER ACRE) TO ANY BARE AREAS OVE 25 SQUARE FEET.
