# An Analysis of the Thermal Performance of Repaired and Replacement Windows

ROBERT SCORE AND BRADFORD S. CARPENTER

**Data and analysis of in-situ thermal monitoring reveal that the repair of aging steel windows offers the opportunity to retain historic building fabric and secure a level of energy performance that can match or exceed that of modern aluminum-framed replacement windows.**

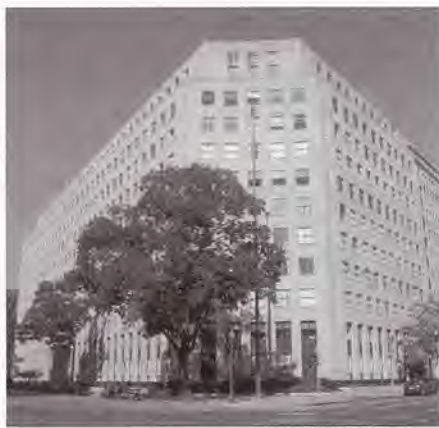
Fig. 1. Southwest elevation, Lafayette Building, Vermont Avenue and H Street NW, Washington, D.C. The building's neoclassical exterior has regularly placed, double-hung steel windows. All images by authors.

One structure currently being considered for such renovation is the Lafayette Building, a federal office building located in downtown Washington, D.C. (Fig. 1). Originally housing the Export-Import Bank of the United States and more recently the Department of Veteran Affairs, the Lafayette Building has had a long and storied history of federal

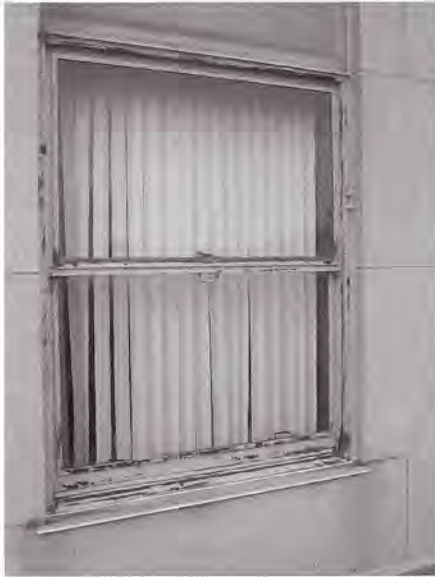
Fig. 2. View of an unrepaired steel-framed window on the east elevation of the Lafayette Building. Note the loss of paint coatings and corrosion of the built-up steel frame.

The building has nearly 1,200 windows along the primary facades and a single interior light court. The windows are constructed of steel shapes and were installed in a double-hung configuration (Fig. 2). The windows are approximately 54 inches wide and 72 inches high and have single glazing without intermediate muntins. Many of the windows exhibit paint flaking and some surface rusting, while others have more significant rusting, particularly at the base of the jambs (Fig. 3). The windows are currently operable and have counterweights in concealed weight pockets. This paper discusses a brief study comparing two options for treating the windows during the planned repair program.

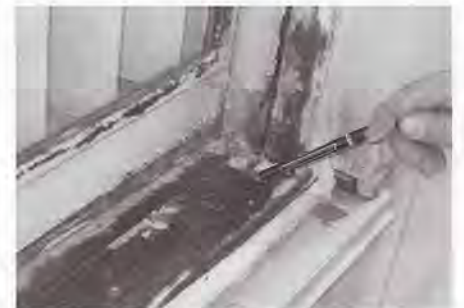
Fig. 3. View of a steel window sill on the east elevation of the eleventh floor. Note the significant corrosion of the steel frame at the sill-to-jamb corner.

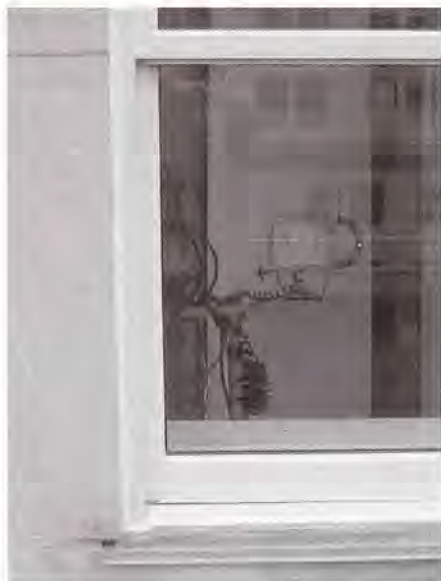
Fig. 4. Sill of the replacement window.

treatments proposed for the actual construction in order to provide accurate results for comparison (Figs. 4 through 7). Mock-ups were installed in the east elevation of the building at the eleventh-floor level based upon input from the owner and design team. The location on the east elevation of the eleventh floor, a height roughly equal with the rooftops of surrounding building, allowed a relatively unobstructed solar exposure and conditions that vary between the diffuse solar radiation of north exposures and the intense solar radiation of south and west exposures.

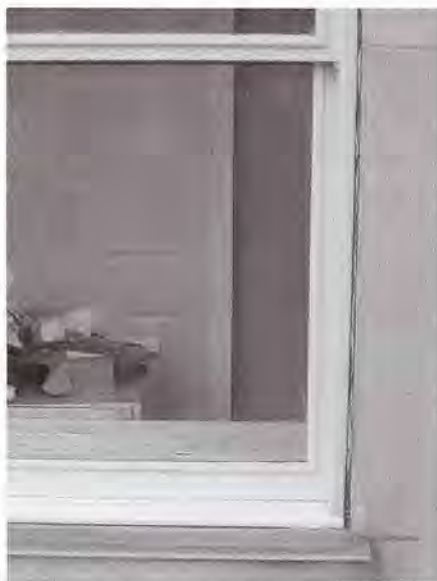
Fig. 5. Sill of the repaired window.

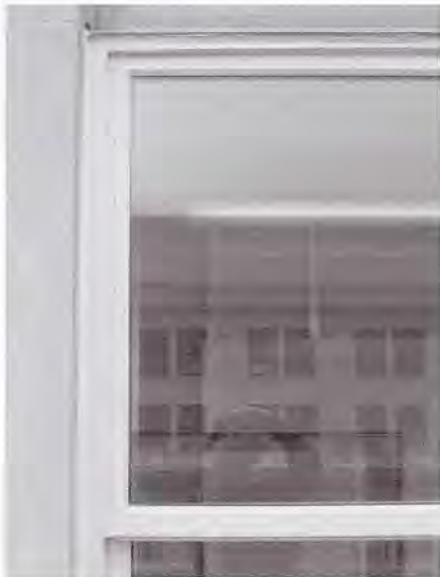
Fig. 6. Head of the replacement window.

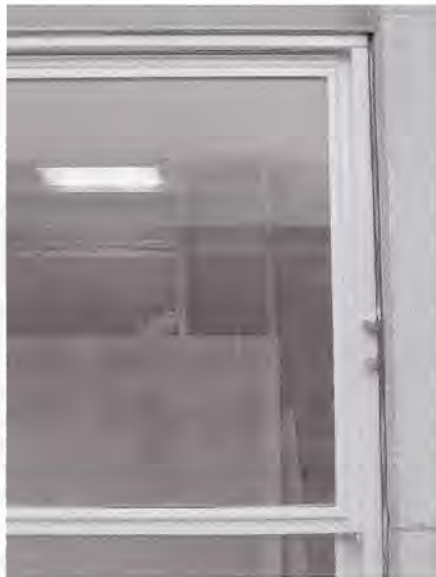
Fig. 7. Head of the repaired window. Note the similar sight lines but missing articulations and accessories of the replacement window when viewed in conjunction with the repaired window.

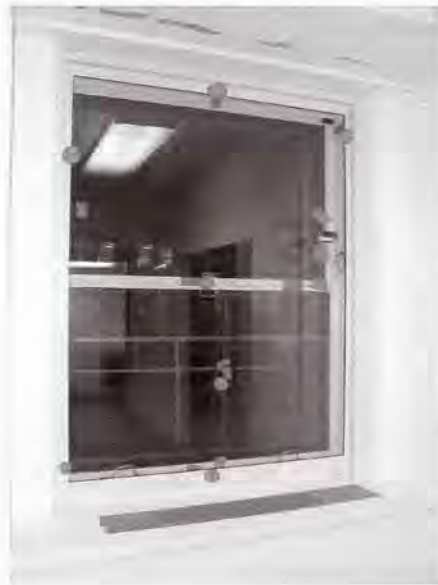
Fig. 8. Interior view of the repaired window prior to installation of the interior chamber. Note the thermal and relative-humidity sensors are indicated with dots. Some sensors are installed on the repaired window, and others are installed on the storm sash, resulting in more sensor locations than on the replacement window.

Both window mock-ups were instrumented with surface-temperature sensors (thermocouples) at critical frame and glass locations where maximum and minimum surface temperatures are expected to occur, such as at the center of the glass, the horizontal meeting rail, and perimeter frame locations. Relative-humidity and air-temperature sensors were also installed within the air cavity between the storm glazing and the exterior window to evaluate condensation potential within the storm cavity (Figs. 8 and 9). Ambient conditions were recorded on the building's exterior and interior, including the pressure differential between the interior and exterior conditions, using relative-humidity and temperature sensors and a digital pressure gauge. Data points for accessible locations were recorded on a laptop computer, while inaccessible data points (temperature and relative humidity within the storm of the rehabilitation window) were recorded on stand-alone data loggers.

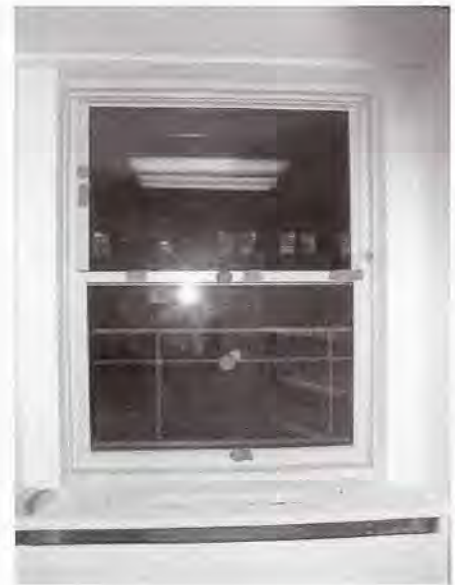
Fig. 9. View of the replacement-window mock-up prior to the installation of the interior chamber. The temperature sensors are indicated with dots.

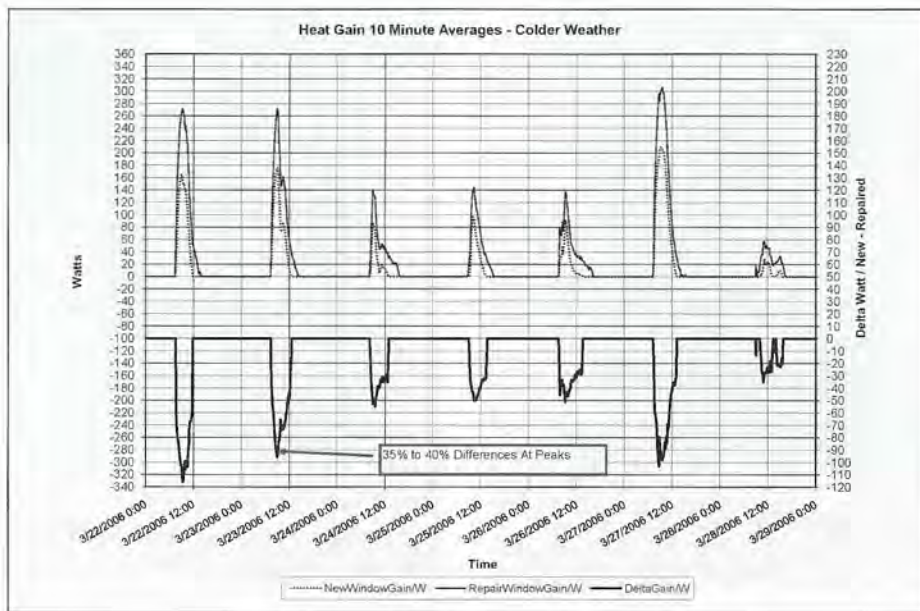
Fig. 10. Heat gain during the coldest week.

**Solar heat gain.** As expected for the east-facing windows, solar heat gain is the largest source of heat gain for the window system and spikes for both window mock-ups in the late morning when the windows are most exposed to sunlight. Heat gain tapers off in the afternoon as direct solar exposure decreases due to indirect diffuse solar exposure. There was a significant difference in peak heat gains between the two mock-up windows (Fig. 10).

Calculations show that the daily peak solar heat gain for the repaired window was approximately 35 to 40 percent greater than for the replacement window during the coldest week of monitoring. In addition, the net heat gain also included reductions in heat gain due to conductive heat loss through the window unit, which was greater for the replacement window, as noted below. As expected, when comparing the measured performance during warmer weather, the difference between the peak heat

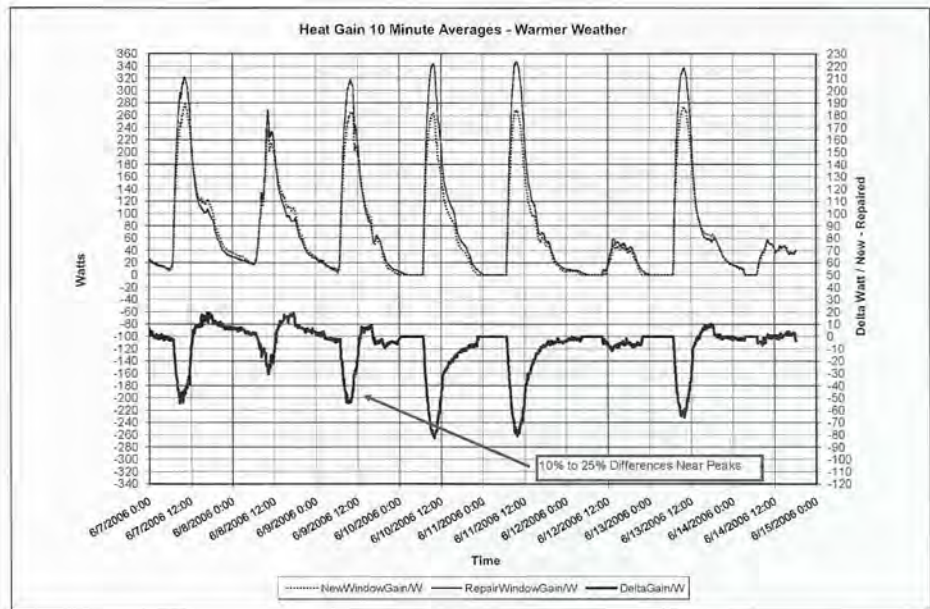
Fig. 11. Heat gain during the warmest week.

gains of the two windows was smaller (Fig. 11).

Calculations reveal that the peak solar heat gain for the repaired window was only 10 to 25 percent greater than that of the replacement window during the warmest week. A comparison with the solar gains during the coldest week illustrates the improved conductive heat gain and loss performance of the repaired window mock-up with respect to the replacement window mock-up. Heat loss was calculated to be 4.0 kW for the replacement window and 1.5 kW for the repaired window during the warmest week. When daytime solar heating conditions (net heat gain for both windows) were considered, a heat gain of 150.6 kW for the replacement window and 169.3 kW for the repaired window was calculated during the coldest week. The net heat gain/loss for the week (excluding conditions where one window is experiencing heat gain or loss and the other window is experiencing the opposite) for each window was found to be 146.6 kW gain for the replacement window and 167.7 kW gain for the

repaired window. The repaired window experienced approximately 15 percent more heat gain during the warm week.

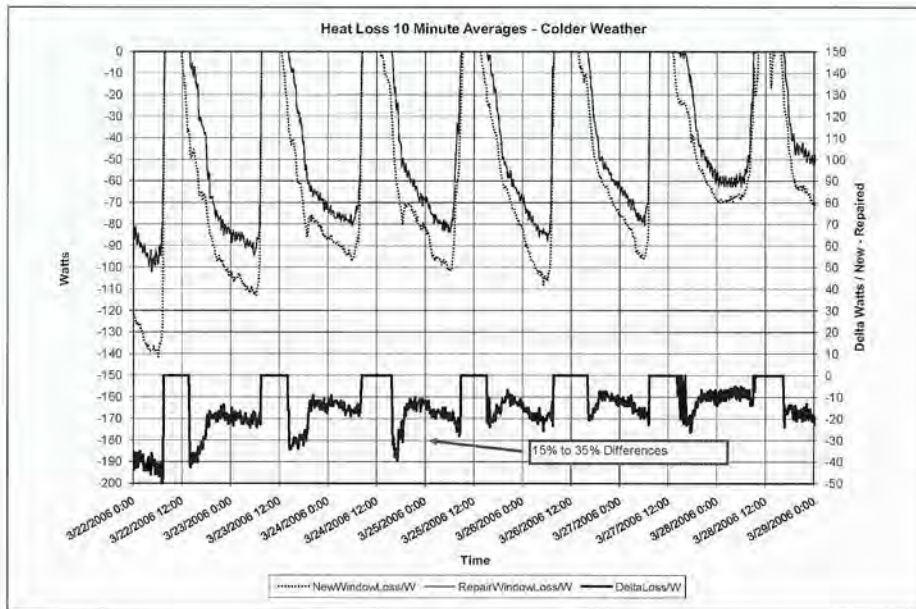
Fig. 12. Heat loss during the coldest week.

The coldest exterior temperatures were observed during the first week of monitoring. Temperatures were not as cold as typical peak winter conditions.<sup>3</sup> However, they provided adequate opportunity to measure window performance during cold weather. Heat-loss data was isolated from the heat-gain data, and the differences in the daily peak heat loss for each of the windows were compared for this cold week (Fig. 12).

As expected, heat-loss peaks occurred in the very early morning hours, before solar heat gain begins. The repaired window experienced 15 to 35 percent less heat loss through the window than the replacement window during the coldest week. Heat loss was calculated to be 121 kW for the replacement window and was 89.5 kW for the repaired window during the week. Considering daytime solar heating conditions (net heat gain for both windows) only, a heat
